**Flood Control Project Maintenance
Levee Inspections
LMA District Cover Sheet
Spring 2012 Levee Inspection Results**

Lake County Watershed Protection District

Spring 2012 Levee Inspection Results

Levee Inspection Report By Mile - Spring 2012

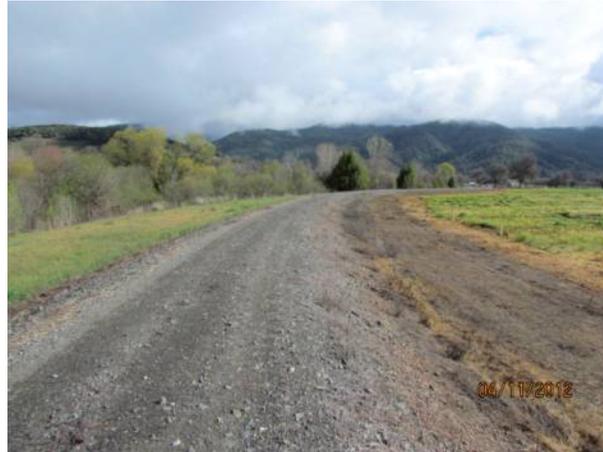
Levee Mile Report Line	4
Start Levee Mile	0.54
End Levee Mile	0.54
Location	Land Side
Category	Earthen Levee
Item	Vegetation
View of the levee with no vegetation on either slope.	
rduffey_s_20120416_591.jpg

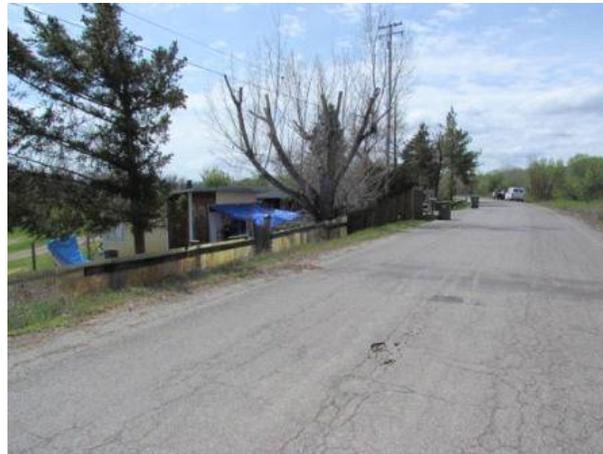
Levee Mile Report Line	8
Start Levee Mile	2.58
End Levee Mile	2.61
Location	Land Side
Category	Earthen Levee
Item	Encroachments
View of the fences at the L/S toe.	
rduffey_s_20120312_358.jpg

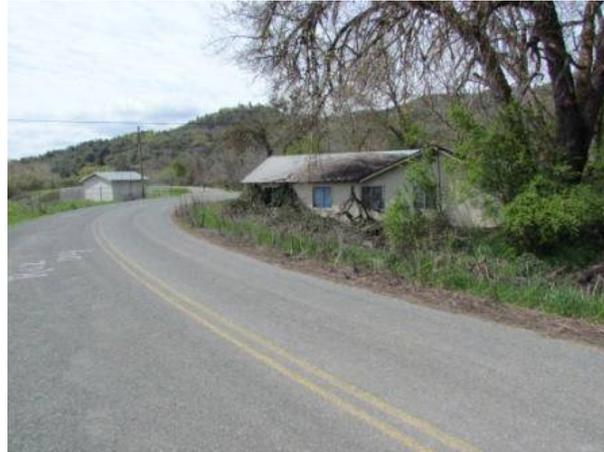
Levee Mile Report Line	3
Start Levee Mile	0.20
End Levee Mile	0.20
Location	Land Side
Category	Earthen Levee
Item	Encroachments
View of the vegetation and building next to the landside toe of levee.	
rduffey_s_20120312_359.jpg

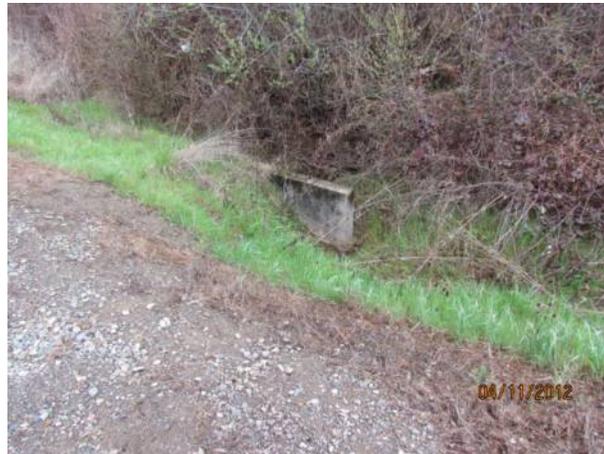
Levee Mile Report Line	4
Start Levee Mile	0.39
End Levee Mile	0.39
Location	Land Side
Category	Earthen Levee
Item	Slope Stability
View of erosion along slope of the levee by both sides of the headwall.	
rduffey_s_20120416_592.jpg

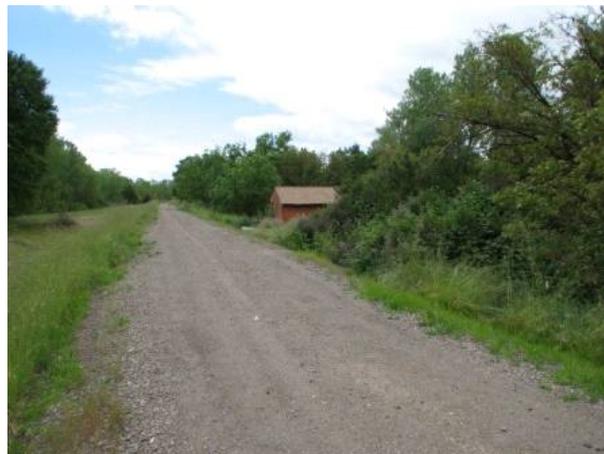
Levee Mile Report Line	6
Start Levee Mile	1.05
End Levee Mile	1.05
Location	Land Side
Category	Earthen Levee
Item	Encroachments
View of building & vegetation along the levee toe.	
rduffey_s_20120312_362.jpg

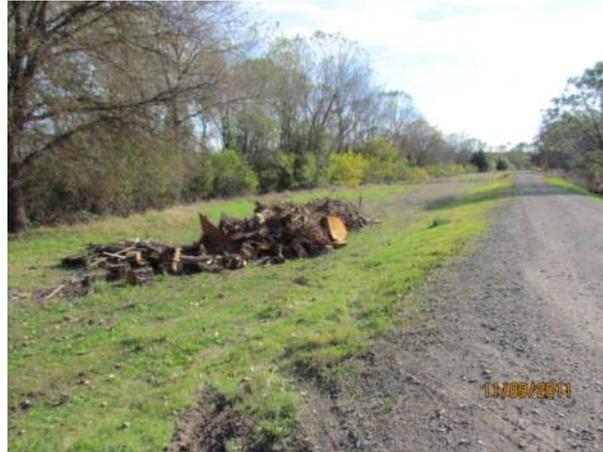
Levee Mile Report Line	7
Start Levee Mile	1.06
End Levee Mile	1.06
Location	Land Side
Category	Earthen Levee
Item	Encroachments
View of the tree prunings on the W/S toe.	
rduffey_s_20120312_361.jpg

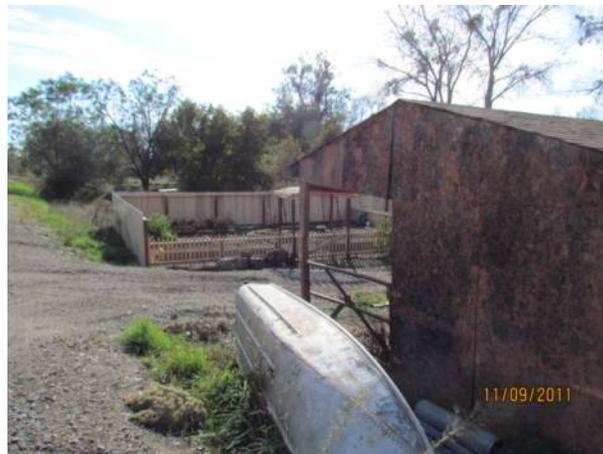
Levee Mile Report Line	8
Start Levee Mile	1.06
End Levee Mile	1.06
Location	Land Side
Category	Earthen Levee
Item	Encroachments
View of the building & fence along the L/S toe.	
rduffey_s_20120312_360.jpg

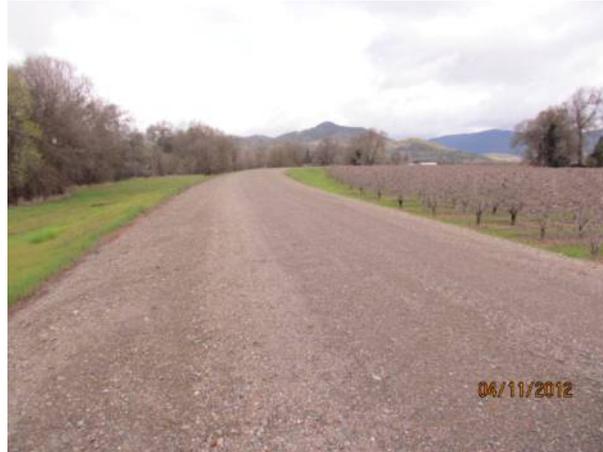
Levee Mile Report Line	3
Start Levee Mile	0.26
End Levee Mile	0.26
Location	Land Side
Category	Earthen Levee
Item	Vegetation
View of the grasses on both slopes of the levee.	
rduffey_s_20120416_593.jpg

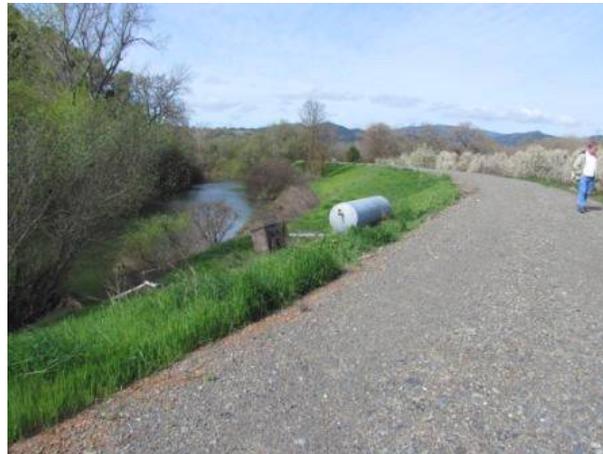
Levee Mile Report Line	4
Start Levee Mile	0.97
End Levee Mile	0.97
Location	Water Side
Category	Earthen Levee
Item	Encroachments
View of a tank that needs to be removed from the W/S slope.	
rduffey_s_20120312_363.jpg

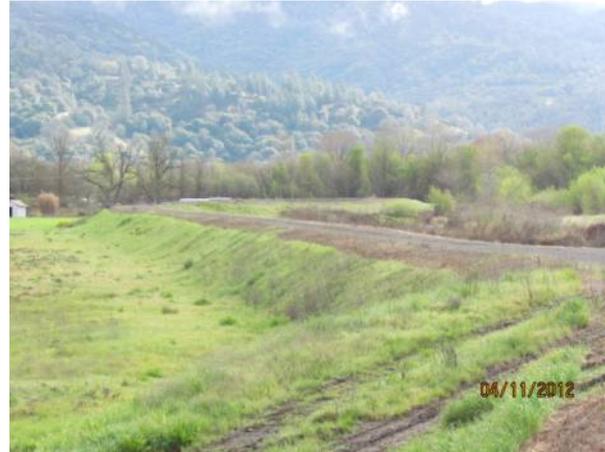
Levee Mile Report Line	1
Start Levee Mile	0.53
End Levee Mile	0.53
Location	Land Side
Category	Earthen Levee
Item	Vegetation
View of the levee with grasses on both slopes.	
rduffey_s_20120416_587.jpg

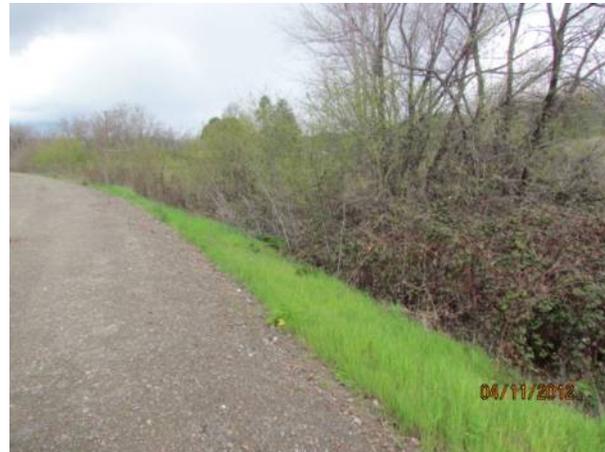
Levee Mile Report Line	4
Start Levee Mile	1.05
End Levee Mile	1.18
Location	Land Side
Category	Earthen Levee
Item	Trim / Thin Trees
Remove the trees and vegetation from the toe of the levee.	
rduffey_s_20120416_590.jpg

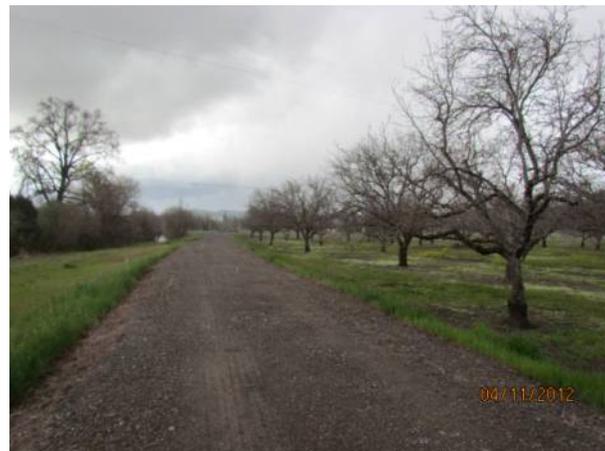
Levee Mile Report Line	5
Start Levee Mile	1.19
End Levee Mile	1.19
Location	Land Side
Category	Earthen Levee
Item	Encroachments
View of the walnut tree prunings along the toe of the levee.	
rduffey_s_20120416_588.jpg

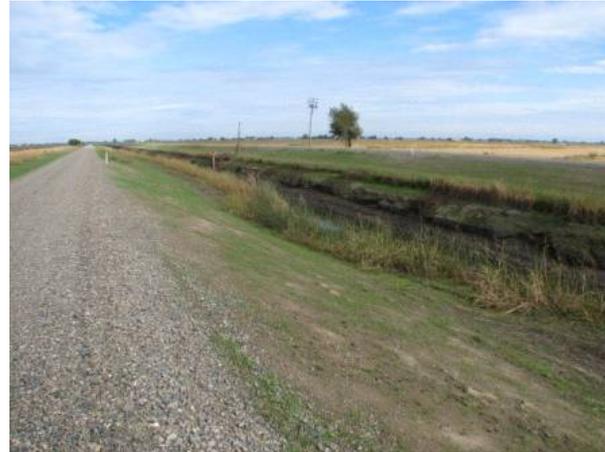
Levee Mile Report Line	1
Start Levee Mile	0.30
End Levee Mile	0.30
Location	Land Side
Category	Earthen Levee
Item	Vegetation

LMIR No.	Levee Mile		Category	Item	Location	Rating	Action/Comment	GPS Latitude/Longitude		Issue No. Photo
	Start	End						Start	End	
1	0.30	0.30	Earthen Levee	Vegetation	LS	M Ma	V4 : Elderberries are blocking visibility and flood fight capability.	39.176957 ° -122.898673 °	39.176957 ° -122.898673 °	3 Y
DWR ID: DWR_NA0009_05_s_2012_3										
2	0.56	0.56	Earthen Levee	Vegetation	LS	A Ma	V1 : Control annual grass and weeds on the levee slopes and easements.	39.175710 ° -122.903032 °	39.175710 ° -122.903032 °	4 Y
DWR ID: DWR_NA0009_05_s_2012_4

View of the elderberries along the landside toe of the levee.

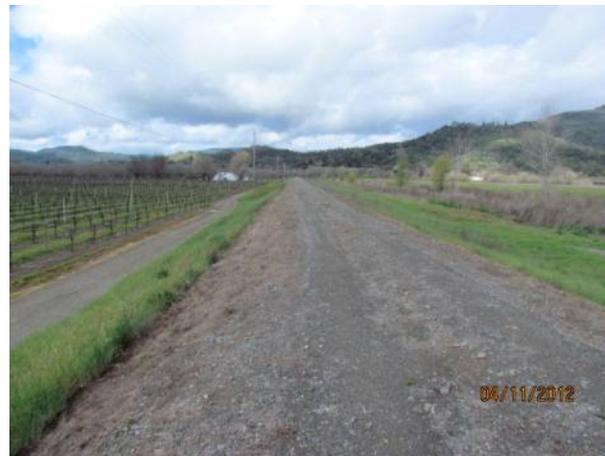
Levee Mile Report Line	2
Start Levee Mile	0.56
End Levee Mile	0.56
Location	Land Side
Category	Earthen Levee
Item	Vegetation

View of the grasses on both slopes.
